*Goleta Bay  
Kelp Anchor  
Demonstration Project*

**Preliminary Site Surveys  
and  
Project Monitoring Reports  
to Date**

Robert Kiel and Greg Christman

September 10, 2017

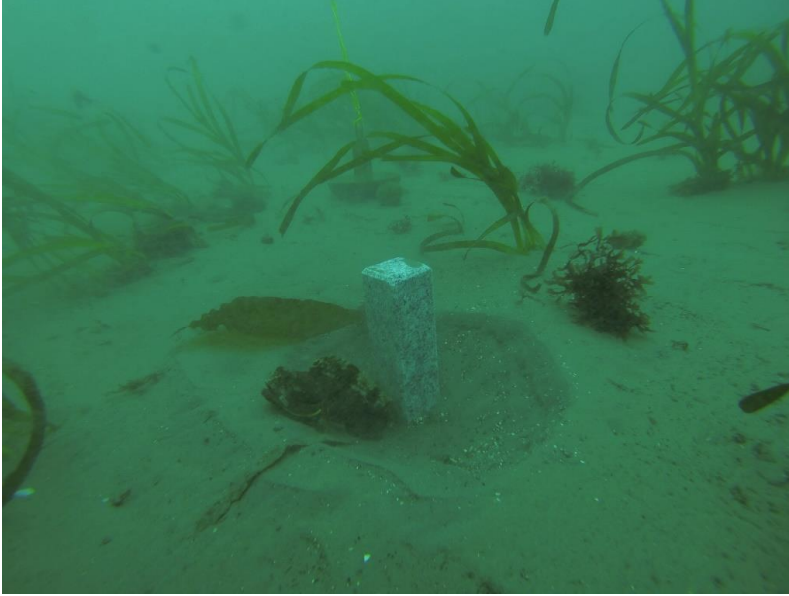
Newly installed granite column, north end of center N-S line of central plot. Note "Sarcastic Fringehead" fish claimed column shortly after it was installed. This fish would attack us when we approached it!

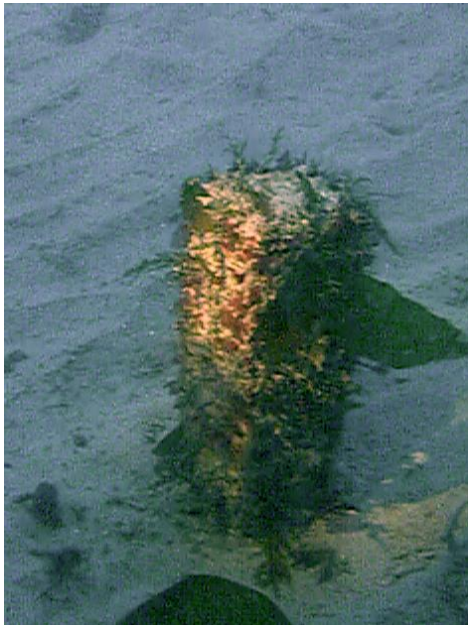
Typical column with algae fuzz growth. Note larger blade is possibly a juvenile *Macrocystis* plant.

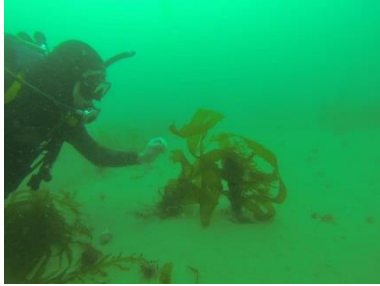
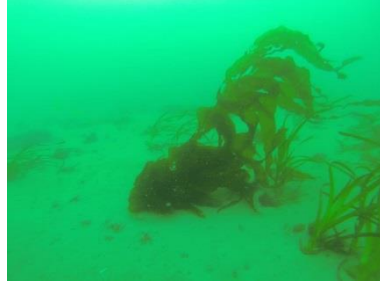
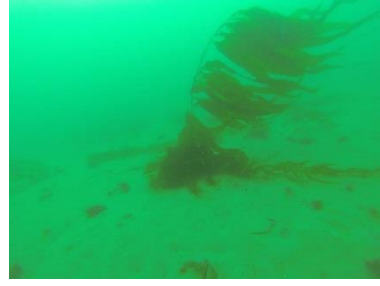
Note sample pictures of kelp plants growing on first 11 columns below.

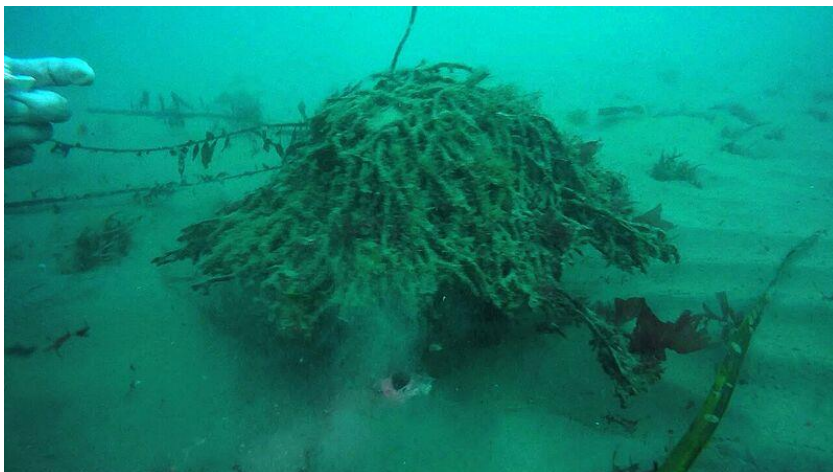
Typical dead holdfast which was growing on one of the initial 11 columns.
